EXHIBIT A
(Kleinfelder Report)

March 11, 2022
Project No. 20224083.001A

**SUBJECT: Geotechnical and Materials Engineering Evaluation
PG&E Claim File No. B19446484
2845 Magnolia Street
Oakland, California**

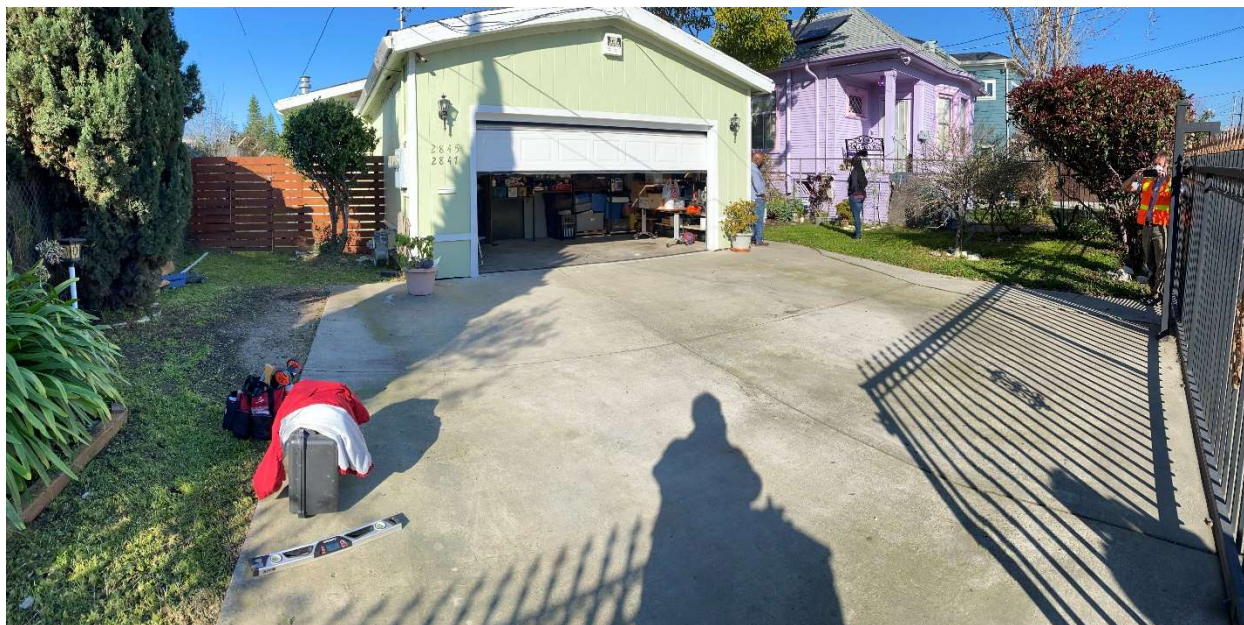
Photo 1. 90-degree Panoramic view of 2845 Magnolia Concrete Driveway area.

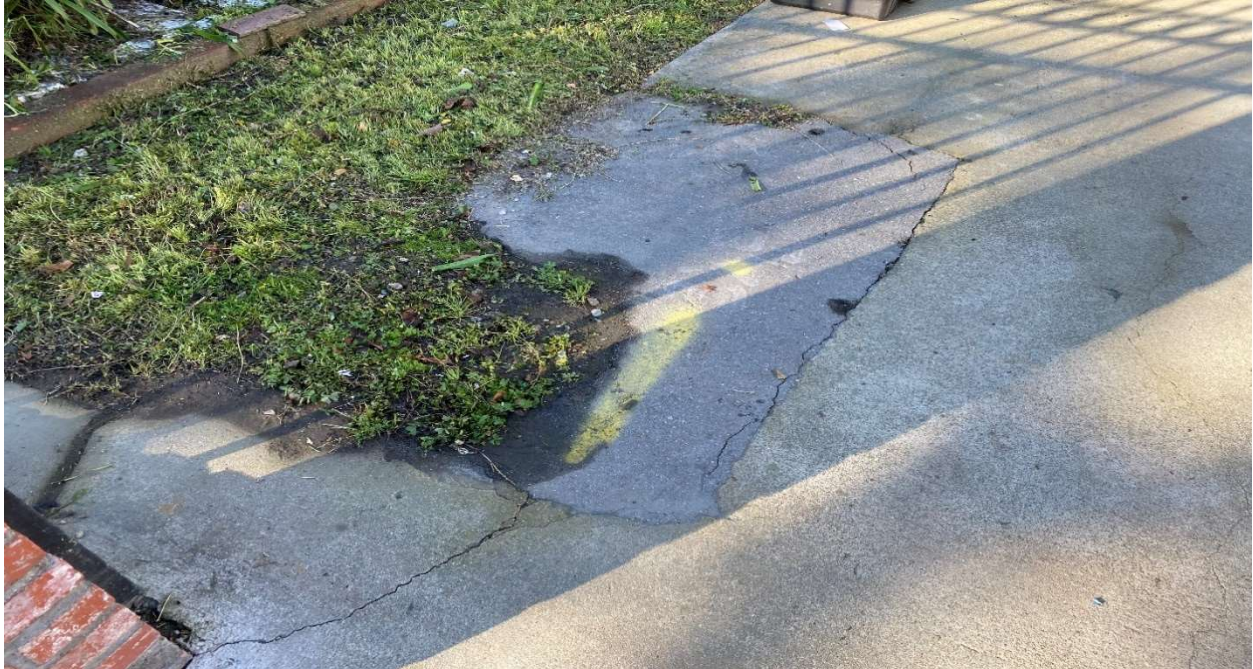
Photo 2. Temporary 3'x5' asphalt concrete patch in southwest corner of driveway by sidewalk.

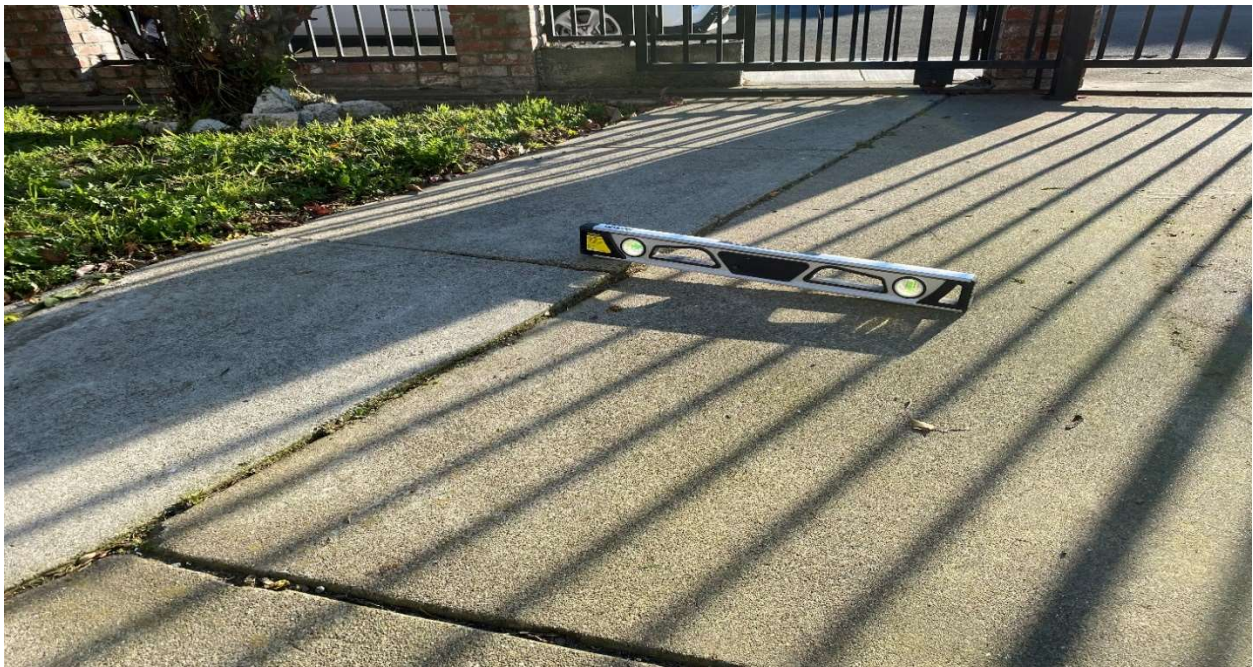
Photo 3. View along transitional walkway and circa 1980s driveway slab (with vertical offset).

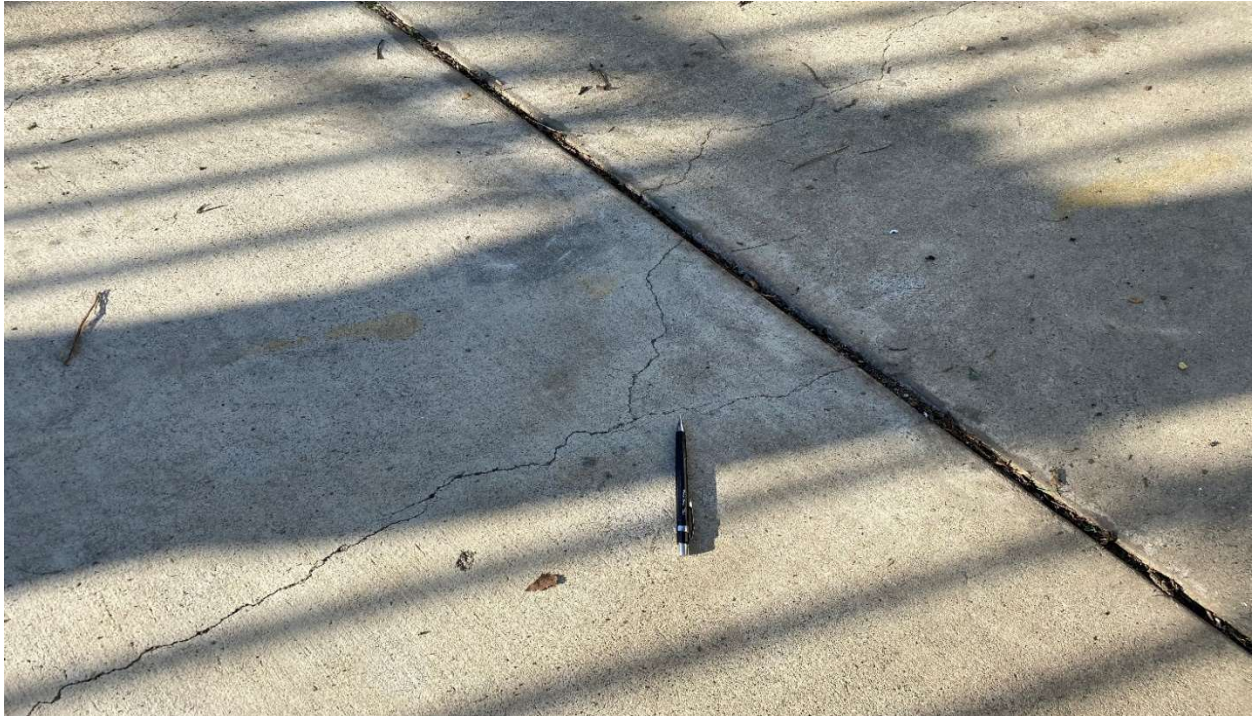
Photo 4. Driveway slab typical shrinkage network cracking.

- Driveway crack widths commonly range in size from "hairline" to 0.028" (see Photos 4 and 5 above).
- Driveway cracks appear to develop as shallow or near-surface features; however, some cracks appear to develop as sectional "through" cracks.

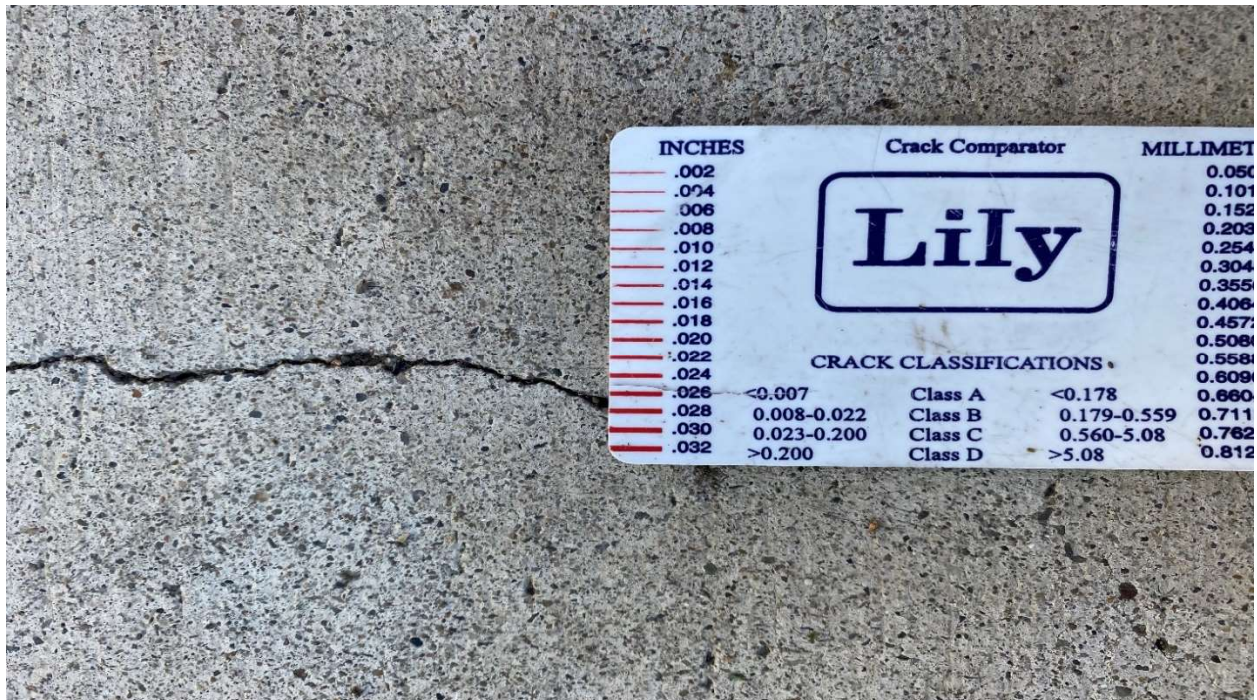
Photo 5. Typical driveway crack width.

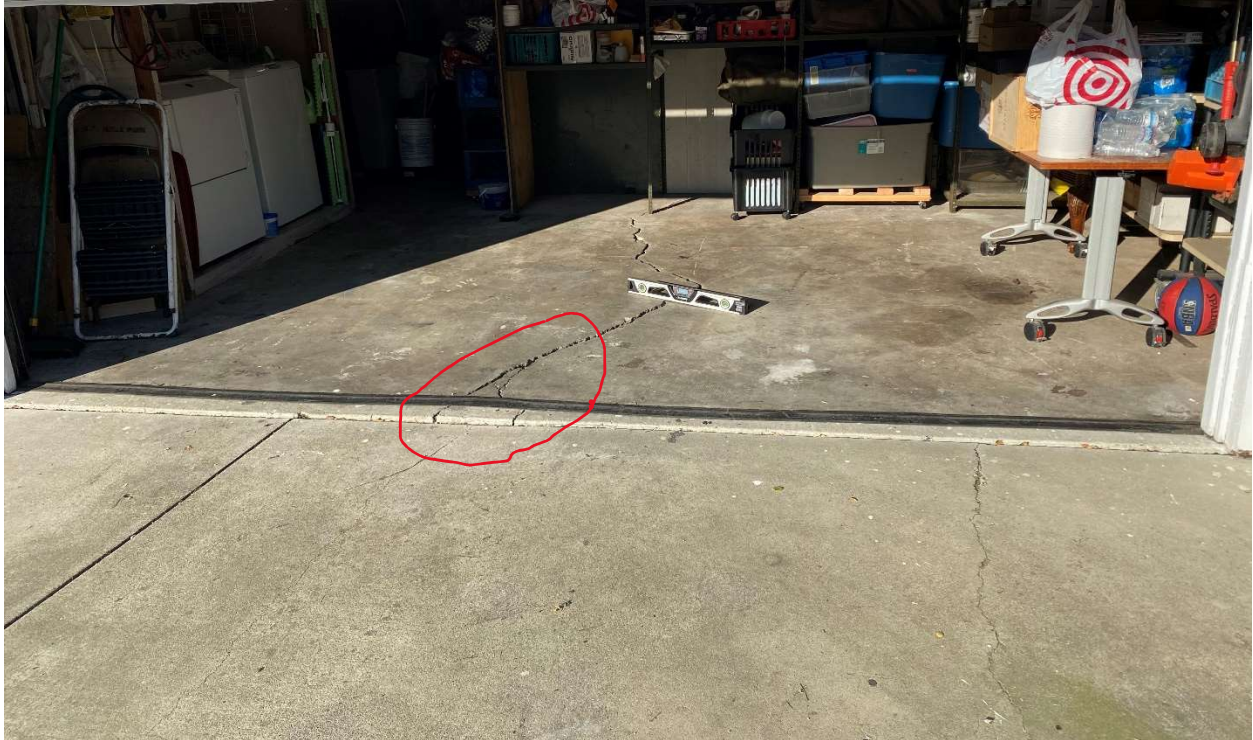
Photo 6. Transition from driveway slab (foreground) to garage floor slab. Close-up area shown in Photo 7 below is indicated in red.

- Typical garage floor slab cracks are noticeably wider than driveway slab cracks and most include vertical offset (see Photos 6 through 11).

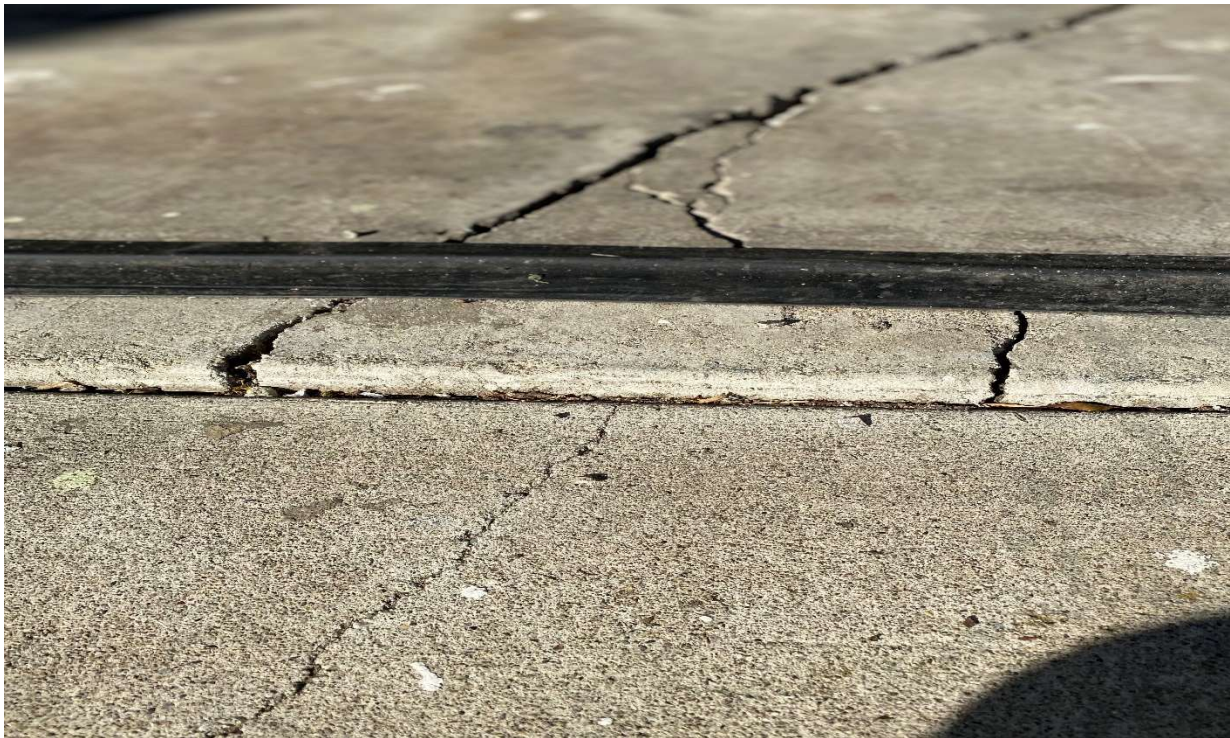
Photo 7. Transition from driveway slab (foreground) to garage floor slab. Note vertical offset and typical difference in crack size between driveway and garage slabs.

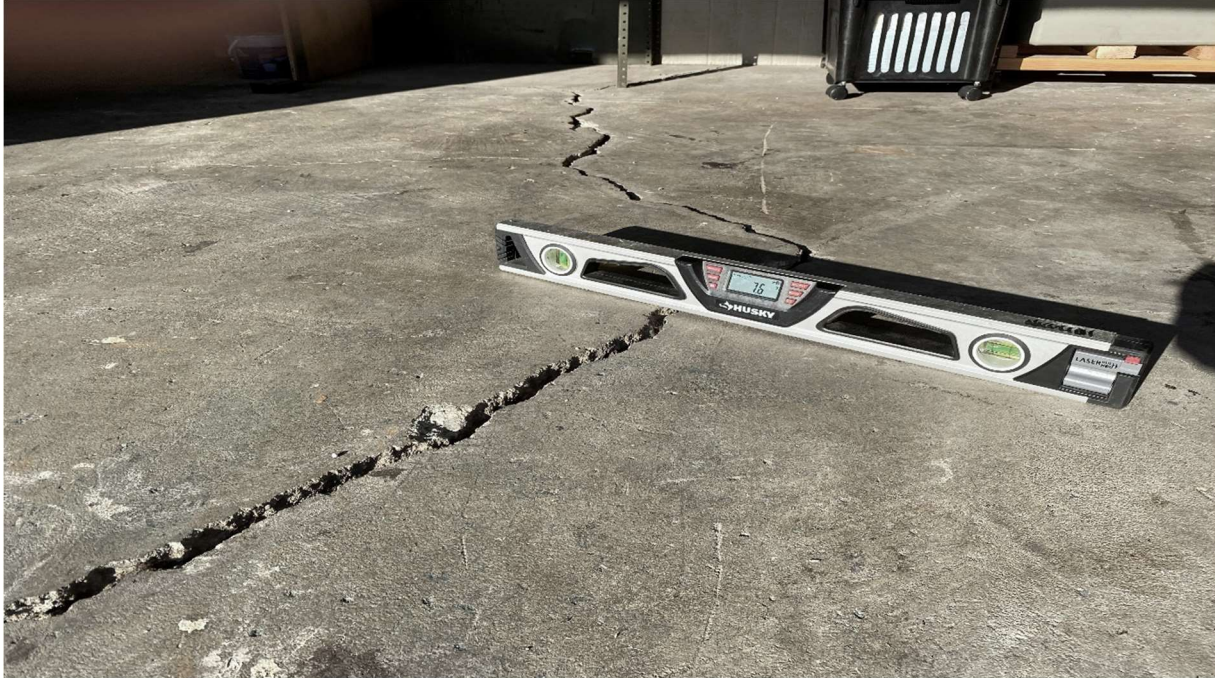
Photo 8. Garage floor crack with typical vertical offset. This slab exhibits a lack of control joinery normally required to assist in directing early stage crack development.

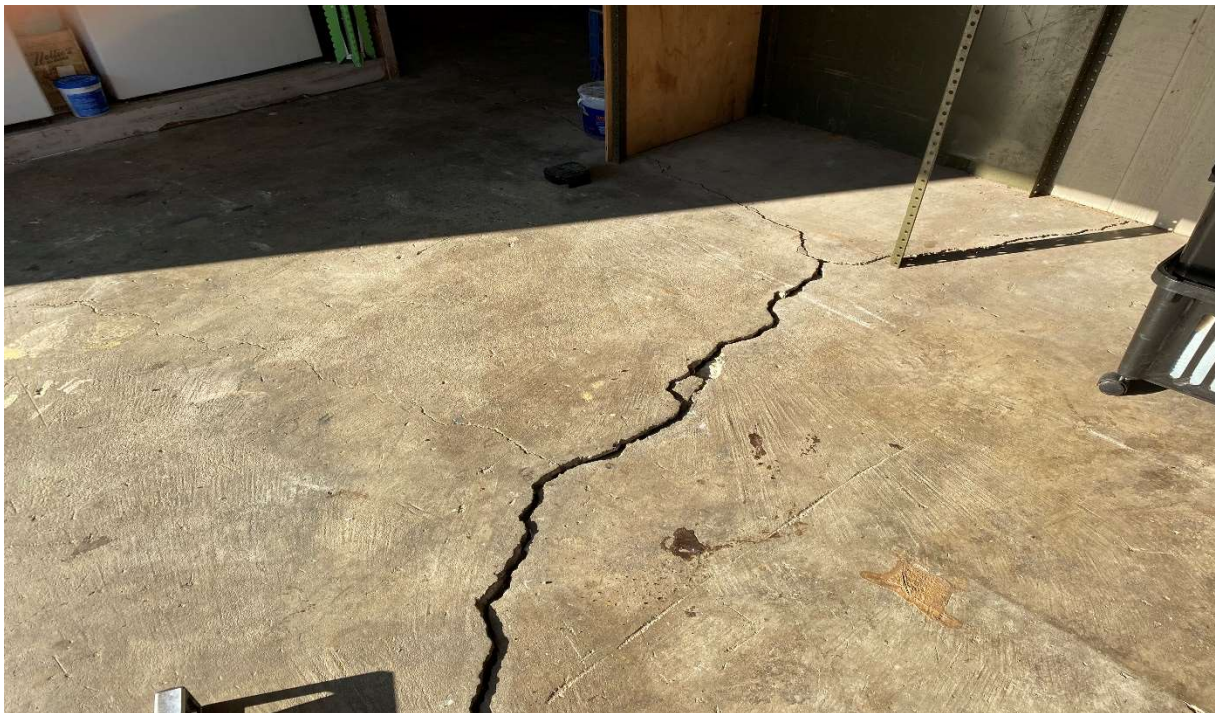
Photo 9. Garage floor network cracking with substantial vertical offset (typical).

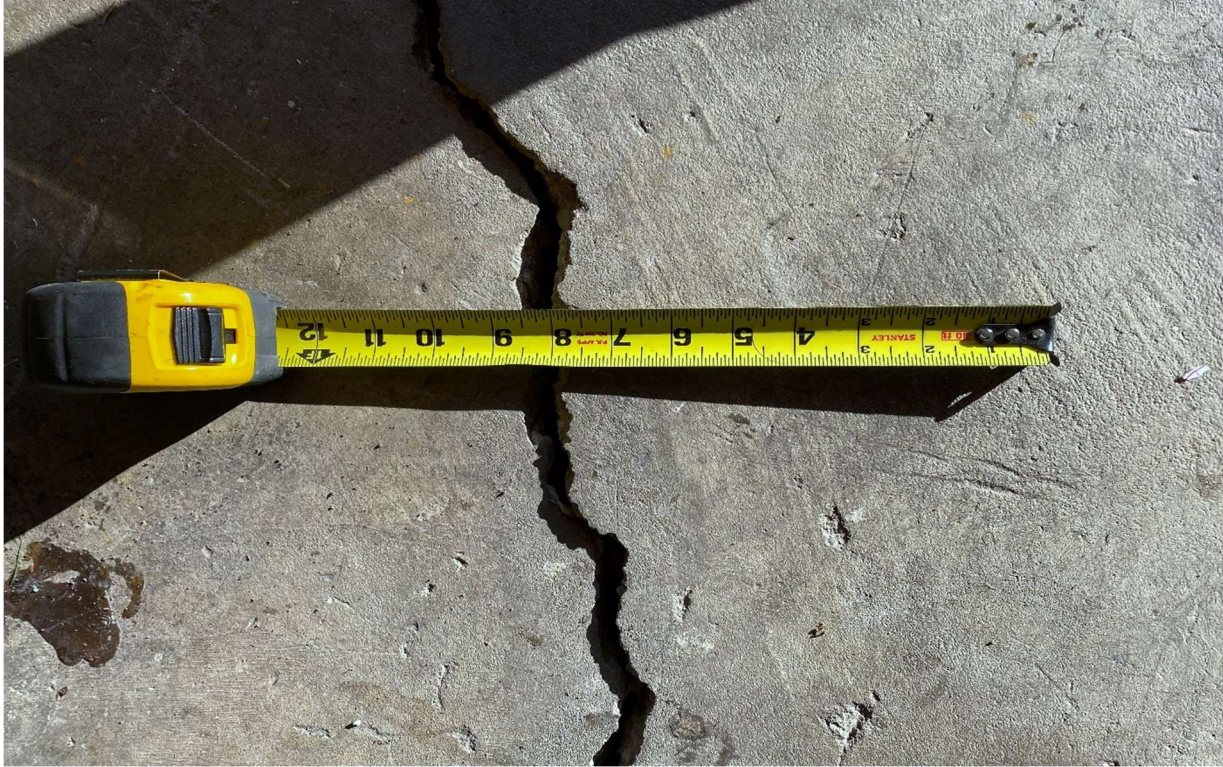
Photo 10. Garage floor crack development and width.

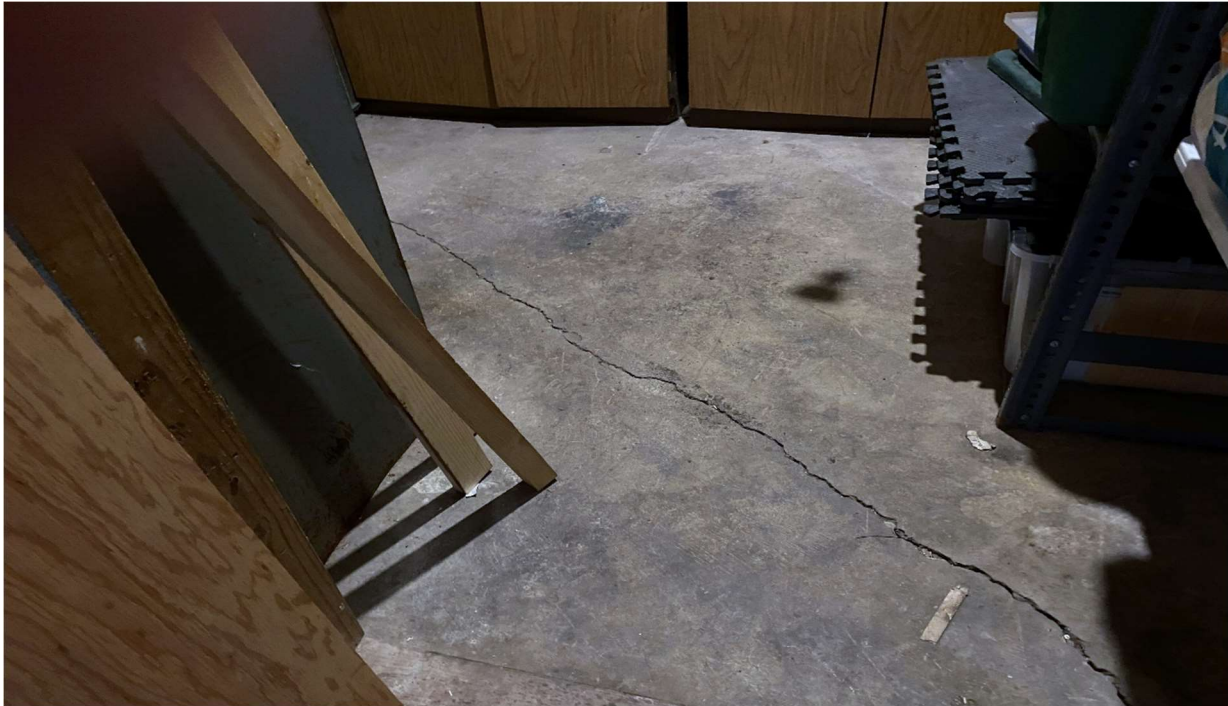
Photo 11. Typical floor crack networking, from near back of garage.

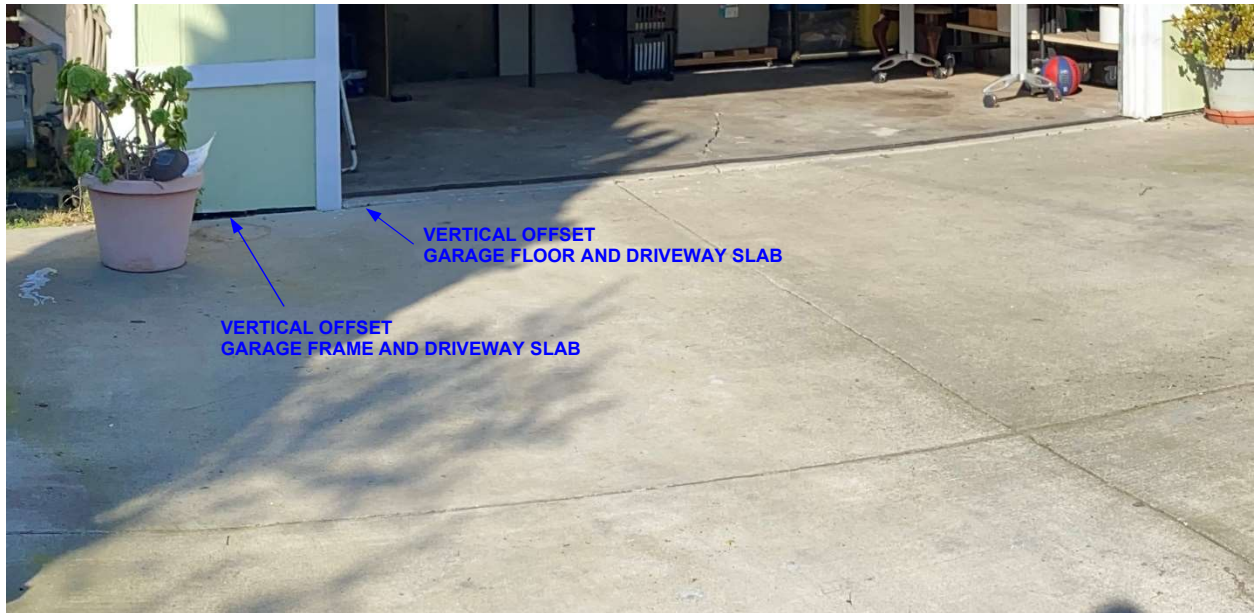
- The observed vertical offset and displacement between the garage door framing and the driveway and garage slab suggest distress as is commonly associated with soils that are prone to shrinkage and swelling.

Photo 12. Vertical offsets between garage frame and floor and driveway. See close-up view in Photo 13 below.

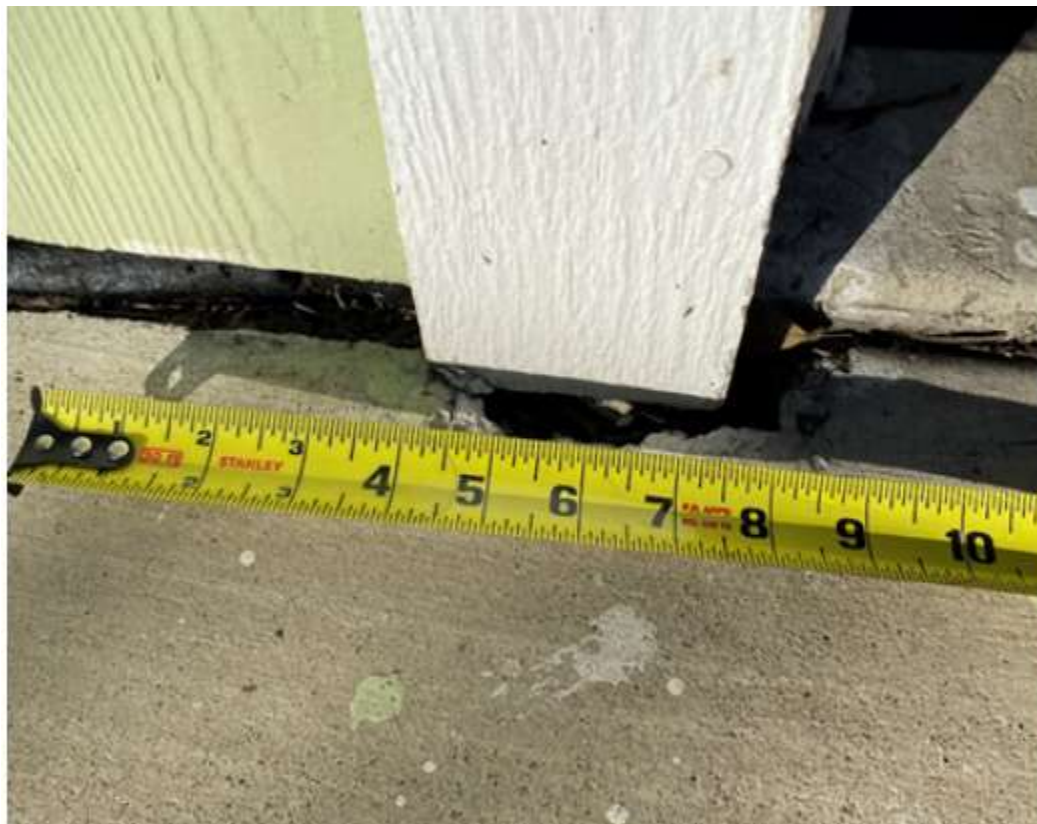
Photo 13. Vertical offset between garage frame and driveway slab, indicating possible volume change in driveway concrete during curing and/or volume change of soils under garage floor and garage frame foundation.

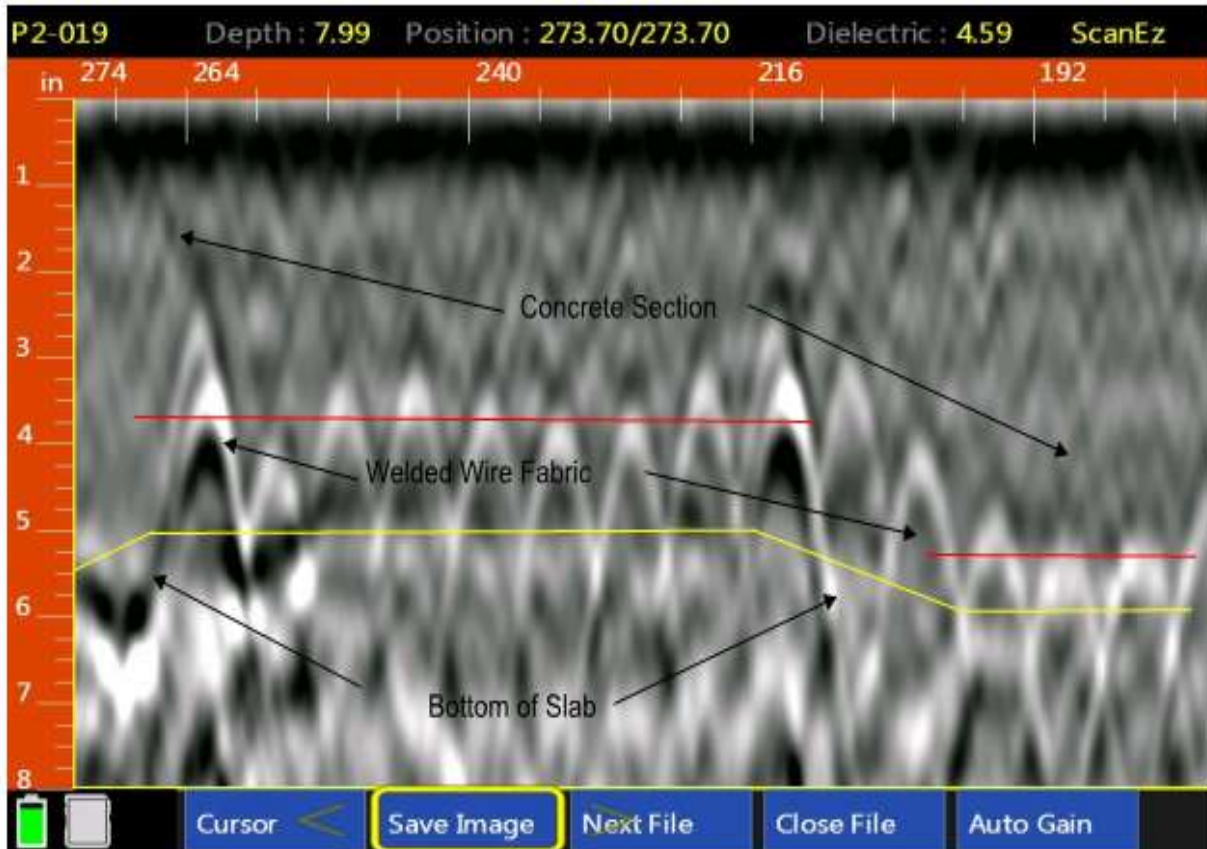
Review of the GPR radiograms suggests variable concrete slab thickness in the driveway slab area. Based upon interpretation of the GPR radiograms, the slab area appears as a nominal 5-inch thick slab with indications of localized thinner sections. The interpreted reinforcing (WWF) appears to be positioned variably in depth throughout the slab thickness and does not appear to be centrally located within the slab thickness and in some instances appears to be positioned in near contact with subgrade soil. Conventional reinforcing detailing requires construction reinforcement of this type to be positioned centrally within the concrete slab section.

Photo 14. Radiogram view of driveway slab showing interpreted concrete section, presence of welded wire fabric reinforcement (3¾" to 4¾" depth), and bottom of concrete slab (5" to 5½" depth).

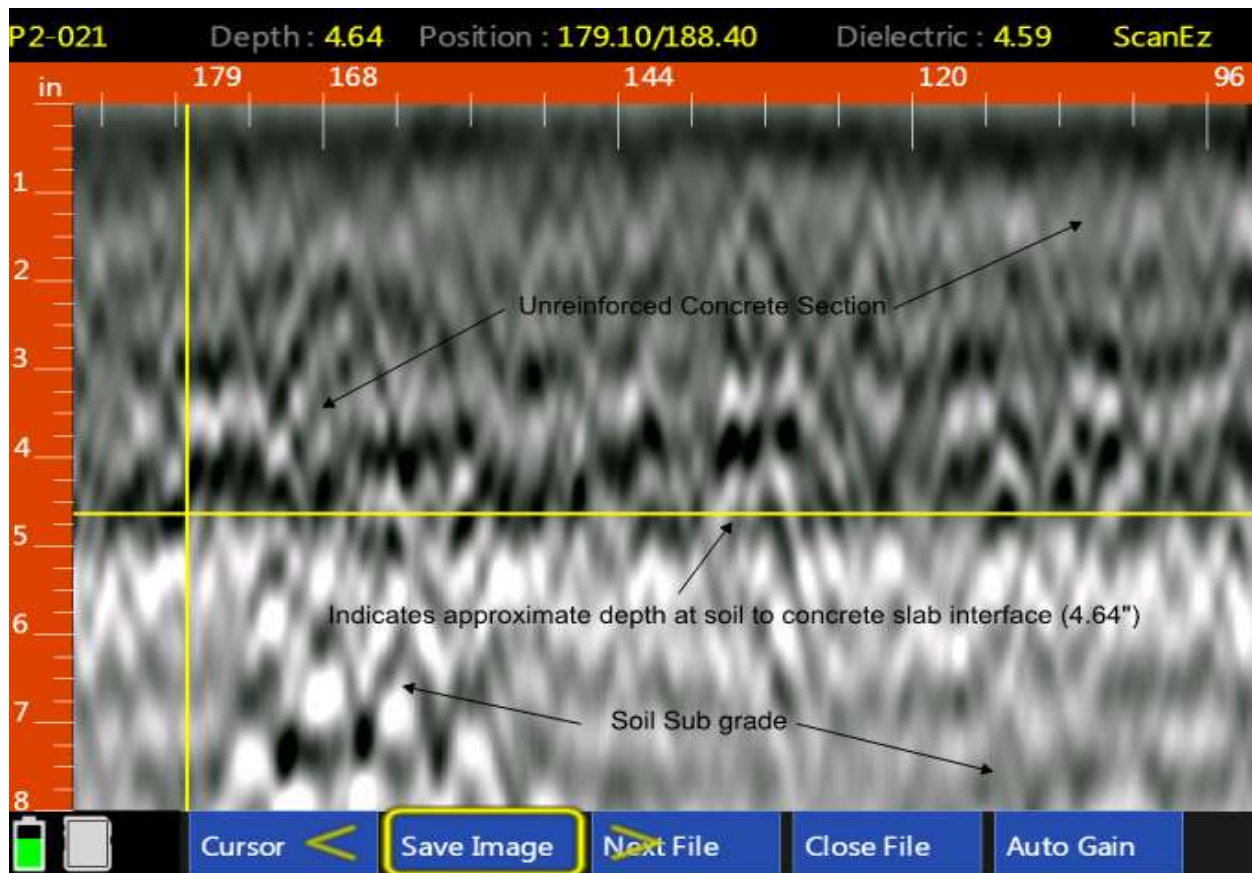
- In Kleinfelder's opinion, the observed cracks in the garage floor are not related in any way to the activities conducted by PG&E in 2016.
 - We found no evidence of steel reinforcement in the garage floor slab (see discussion of GPR soundings below).

Photo 15. Radiogram view of garage floor slab showing interpreted concrete section thickness (roughly 4½" thickness). The radiograms gathered for the garage slab showed no evidence of steel reinforcement.

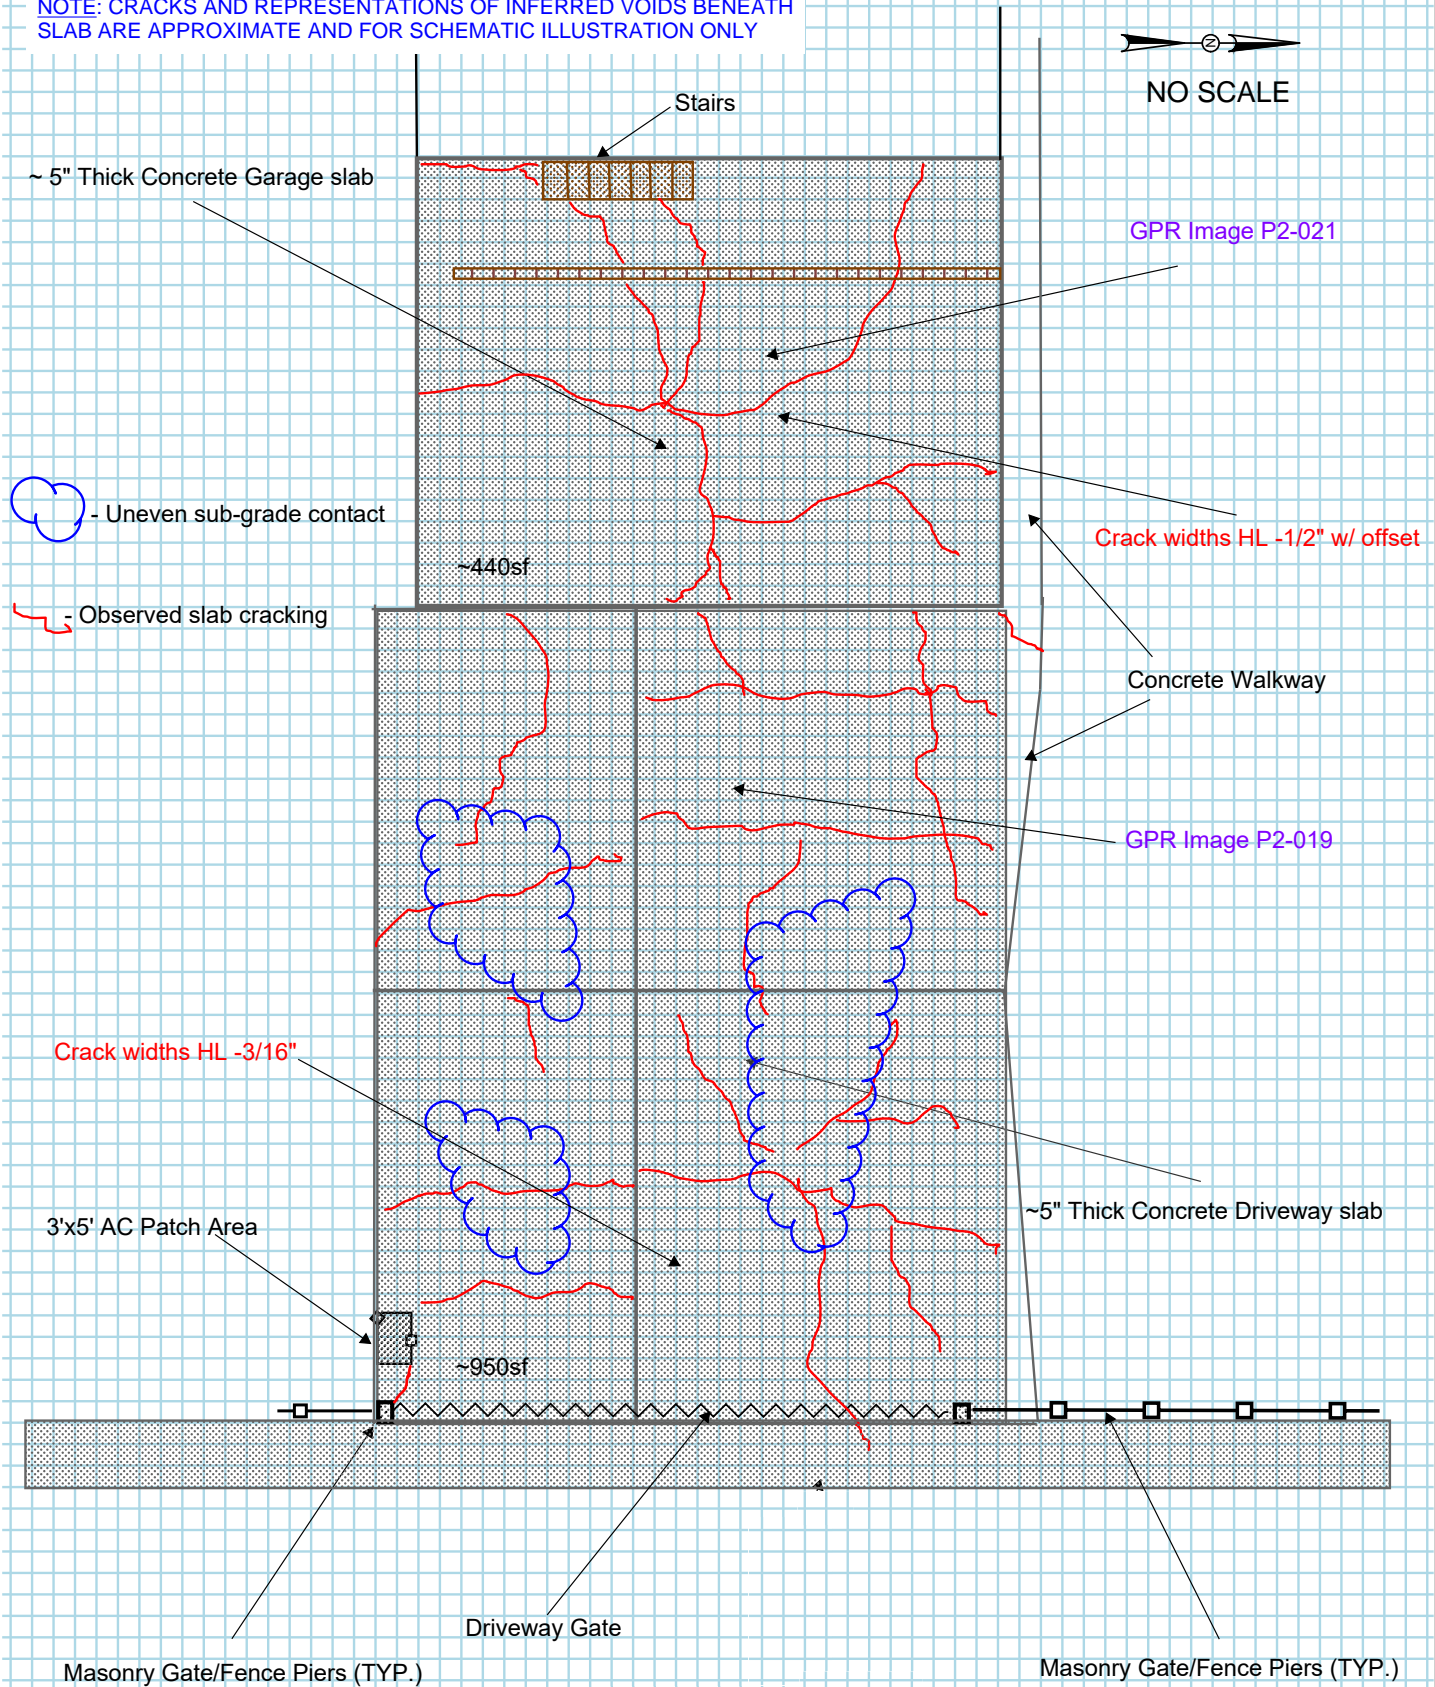
Figure 1 – Schematic Driveway Plan

NOTE: CRACKS AND REPRESENTATIONS OF INFERRED VOIDS BENEATH SLAB ARE APPROXIMATE AND FOR SCHEMATIC ILLUSTRATION ONLY
